The Achievement of Safety Management in Arab Potash Company

Omer Nawaf Maaitah and Salloom Al-Juboori*

Faculty of Engineering, Mutah University, Karak, Jordan.

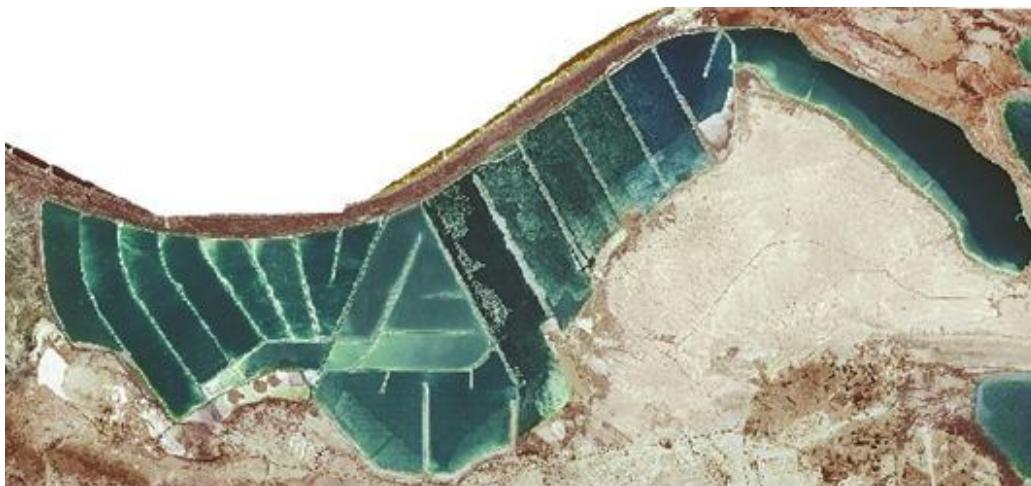
Figure 1. Solar evaporation system.

At the heart of the Ghor El-Safi site are a 112 km² solar evaporation ponds system and ore processing plants. The brine from the Dead Sea is pumped at a yearly average rate of 350 million into the solar evaporation system by main intake pumping station, where the initial concentration process is undertaken at the salt ponds where NaCl deposits. The remaining brine is pumped into the Carnallite ponds, to precipitate the raw Carnallite (Figure 1).

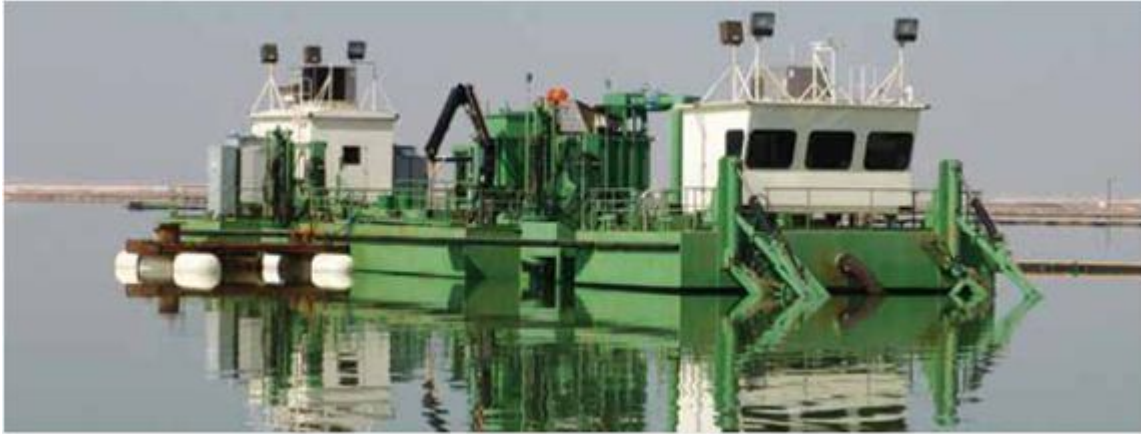
Figure 2. Pumping station.

The precipitated raw Carnallite is the raw material for producing potash. It is precipitated as mixture of Carnallite ($\text{KCl} \cdot \text{MgCl}_2 \cdot 6\text{H}_2\text{O}$) and NaCl. This bed is harvested as a slurry from beneath the brine and delivered to booster pumps on the dikes and then to the refinery through floating pipes (Figures 2 and 3).

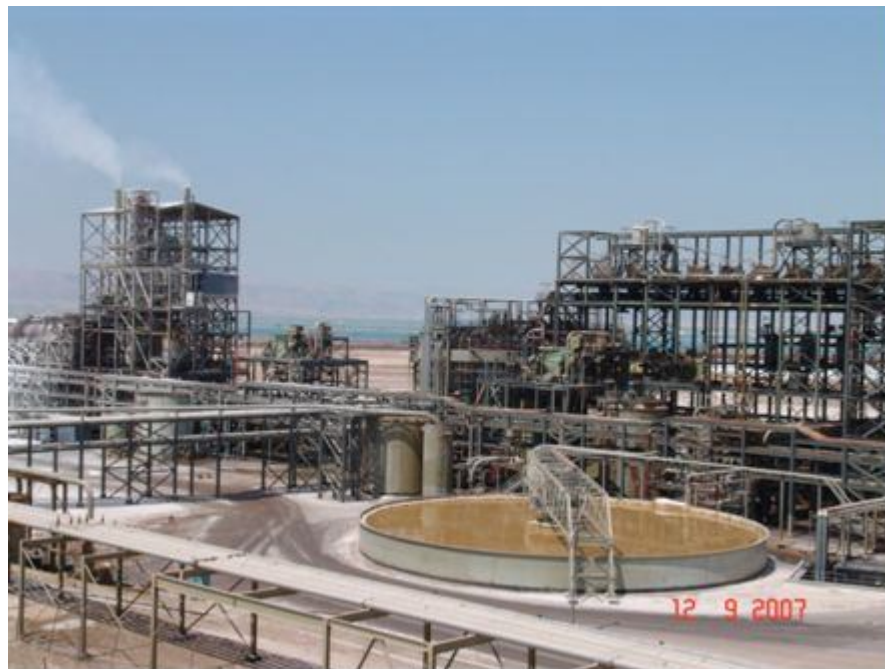
Figure 3. The refineries.

The cooling slurry is added from top, and insures good distribution of the penetrated pans. (Figure 3).
